**2016 Hard Surface Road  
Assessment and Ten-Year  
Capital Plan**

Rural Municipality of St. Clements

Prepared by:  
Stantec Consulting Ltd.  
500-311 Portage Ave  
Winnipeg, MB R3B 2B9

Project No. 113707070  
November 2016

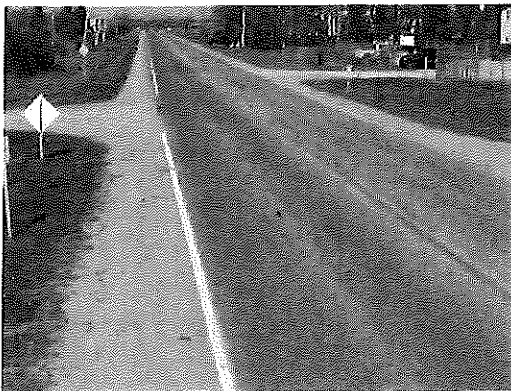
**Road Score 9** – The asphalt pavement is smooth and generally free of distresses. Minor maintenance in the form of routing and sealing may be required, but no major work is currently required or projected within the next 10-years.

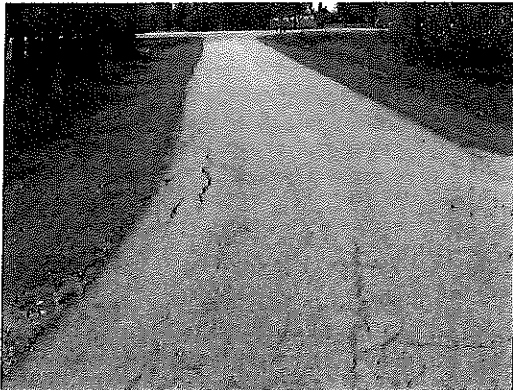
**Road Score 5** – The asphalt pavement is moderate and the pavement surface is weathered. The pavement shows signs of structural damage. Immediate needs for the pavement may be continued maintenance in the form of routing and sealing and occasional localized patching. However, it is anticipated that the pavement will require some form of rehabilitation in the coming years.

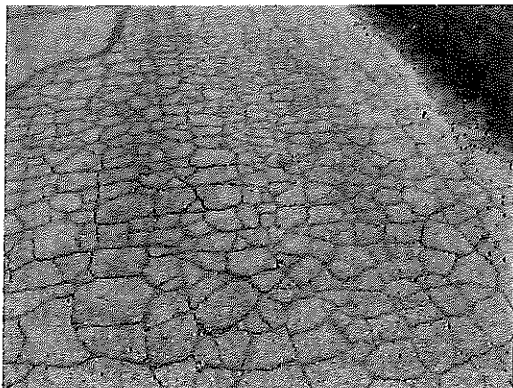
**Road Score 1** – The pavement surface is cracked and disintegrated. Structural damage is widespread. The ride has deteriorated to the point where traffic operations are affected as rideability is non-existent. Reconstruction is required as it is most probable that the pavement has exceeded its useful life and experiences sub-grade failure.
